Phipps Conservatory Broderie & East Rooms Roof Restoration

Squirrel Hill Urban Coalition (SHUC)
October 11th, 2022

OLD CONSERVATORY ROOF RESTORATION CAMPAIGN

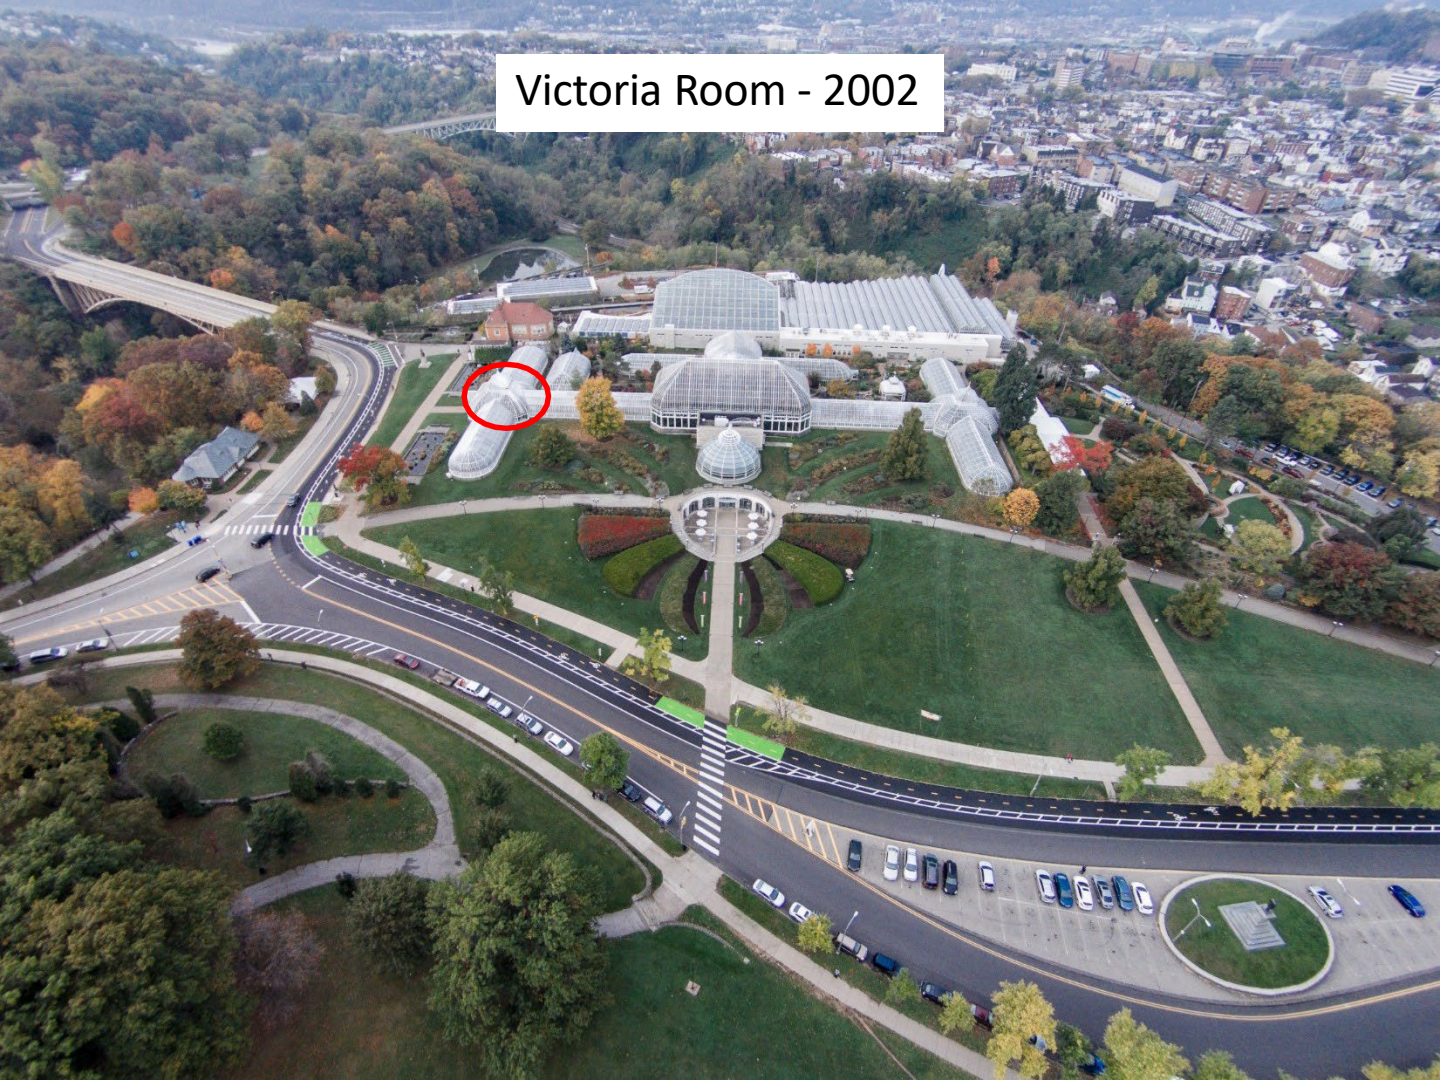
Victoria Room - 2002

Victoria Room – Roof Preservation (2002)

Replicated wood rafter profiles in aluminum with high performance white coating, new safety laminated glass, restored cresting and finial and automated roof vent sash.

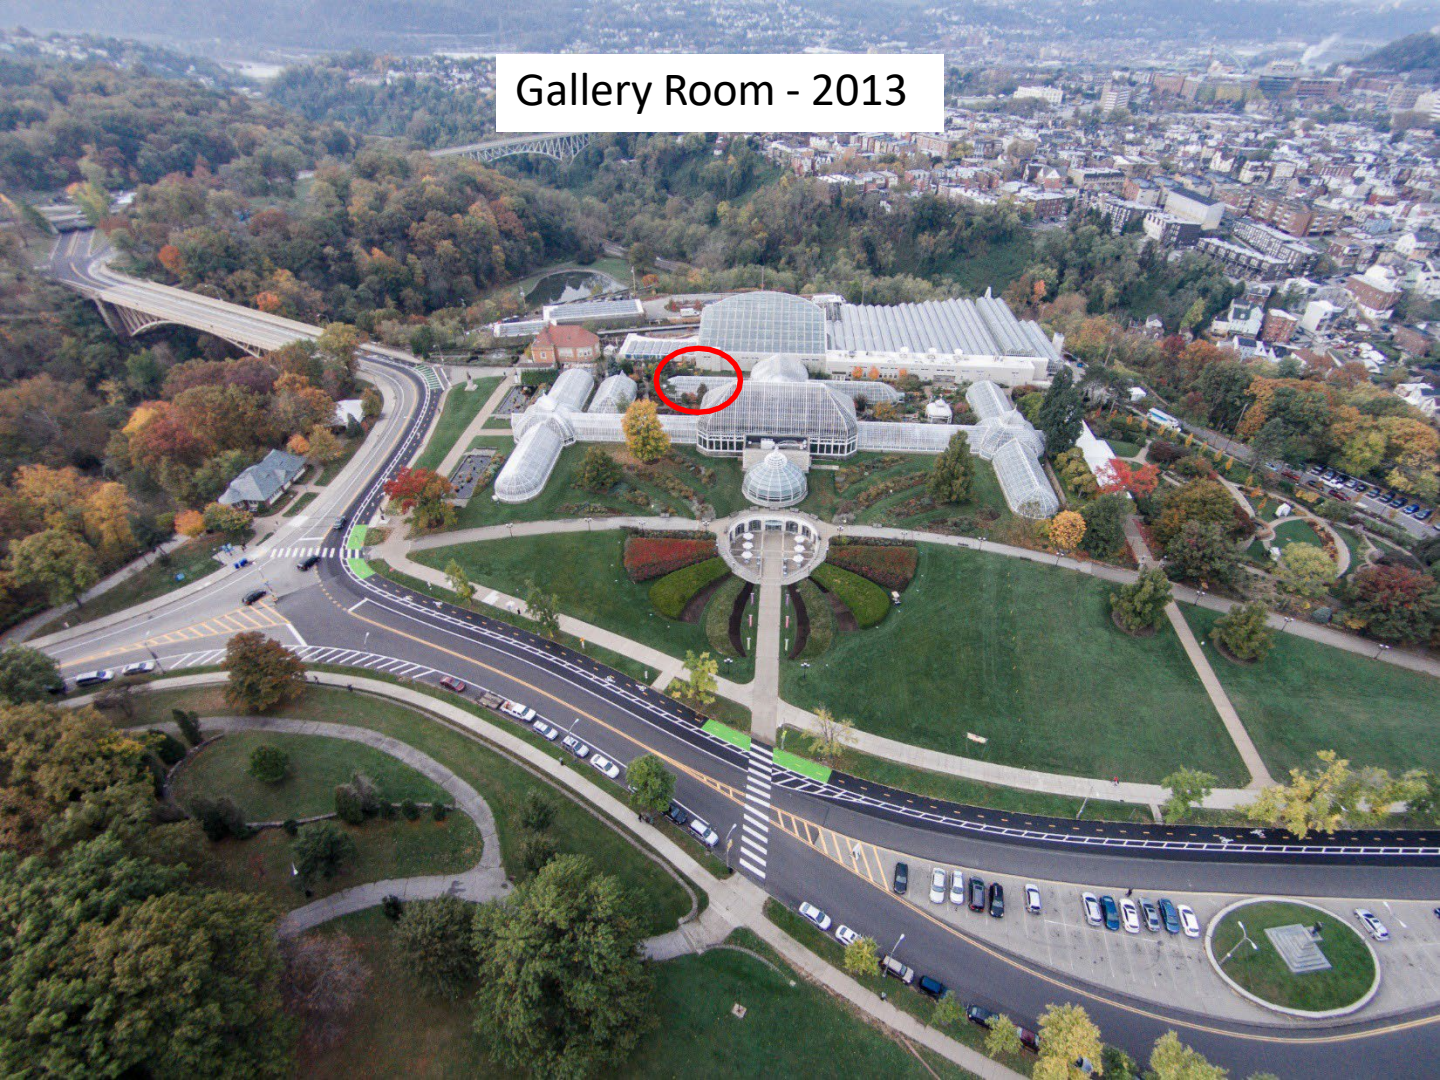
Gallery Room - 2013

Gallery Room– Roof Preservation (2013)

Replicated wood rafter profiles in aluminum with high performance white coating, new safety laminated glass.

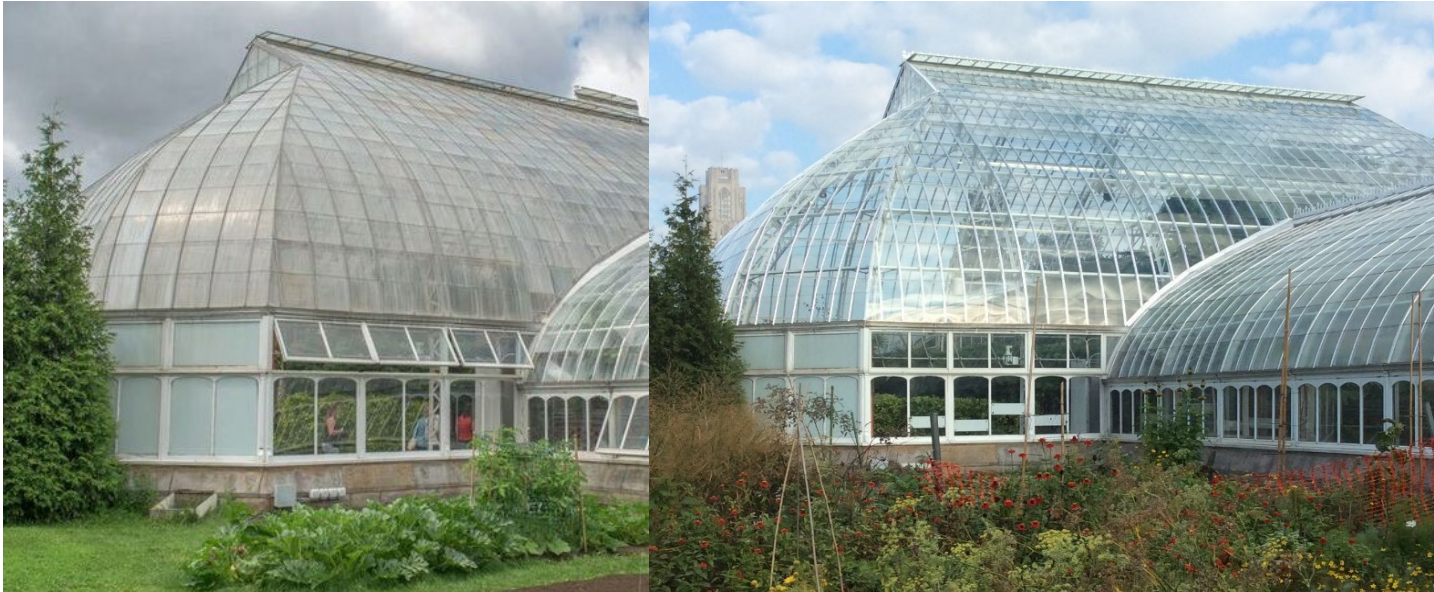
South Conservatory– Roof Preservation (2015)

Replicated wood rafter profiles in aluminum with high performance white coating, new safety laminated glass. Return historic glass spacing, sizing and ornamental cresting ridge element.

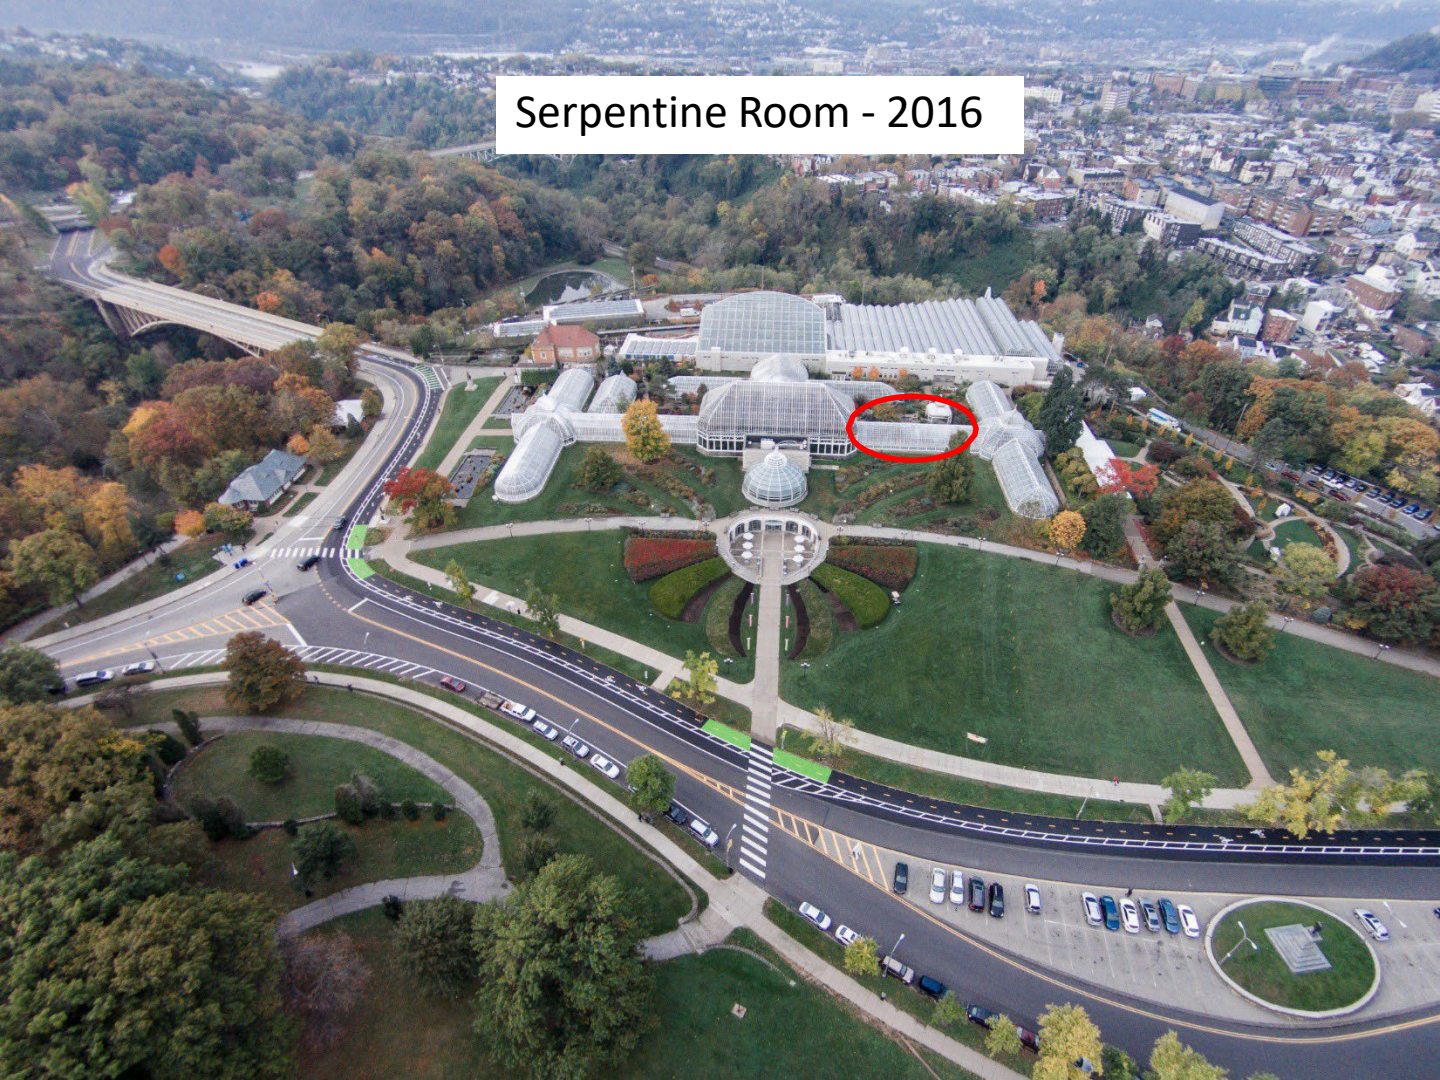
Serpentine Room - 2016

Serpentine Room - Roof Preservation (2016)

Replicated wood rafter profiles in aluminum with high performance white coating, new safety laminated glass.

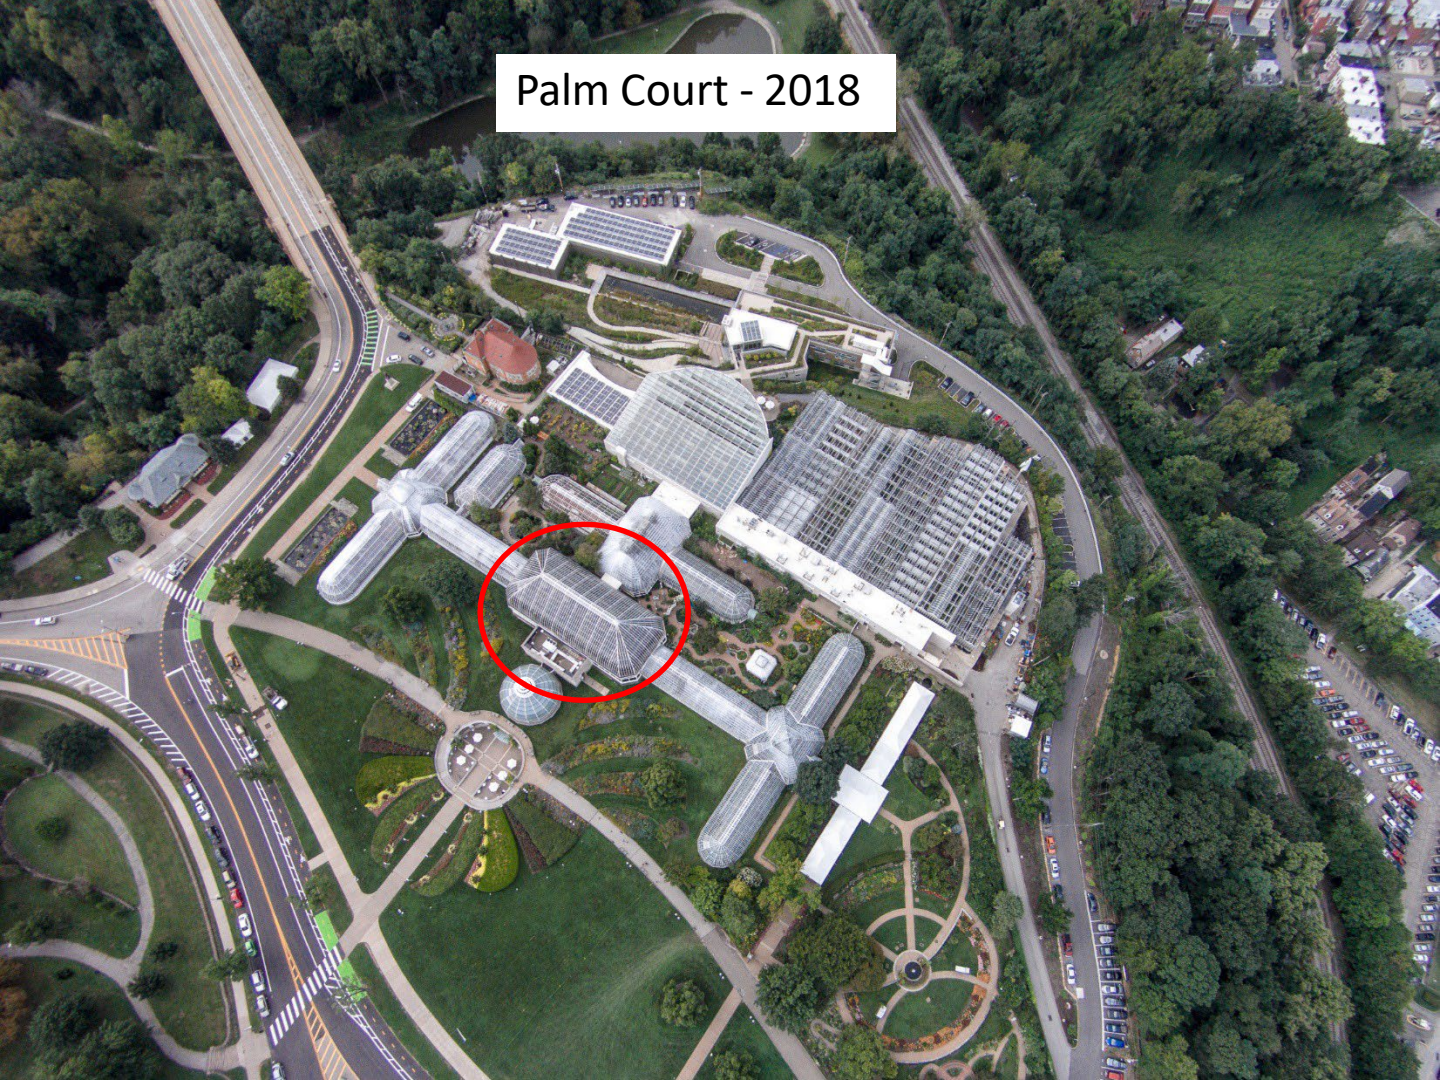
Palm Court - 2018

Palm Court - Roof Preservation (2018)

Replicated wood rafter profiles in aluminum with high performance white coating, new safety laminated glass, returned Historic Ogee Roof Structure and ornamental features .

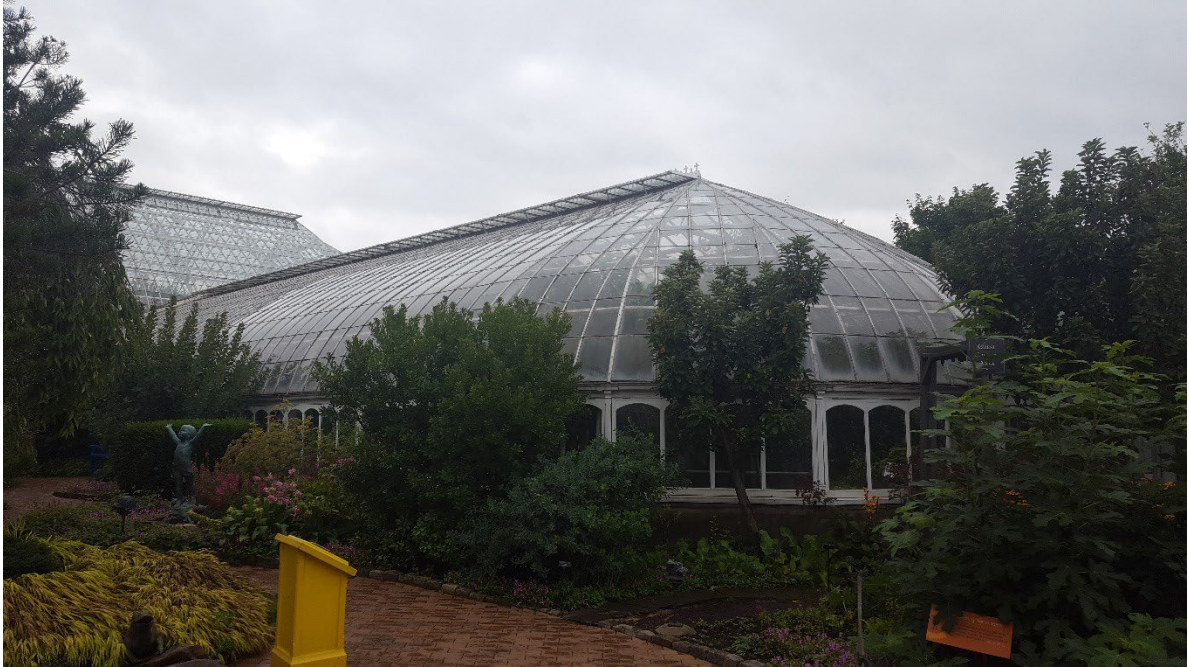
Fruit & Spice Room – Roof Preservation (2019)

Replicated wood rafter profiles in aluminum with high performance white coating, new safety laminated glass.

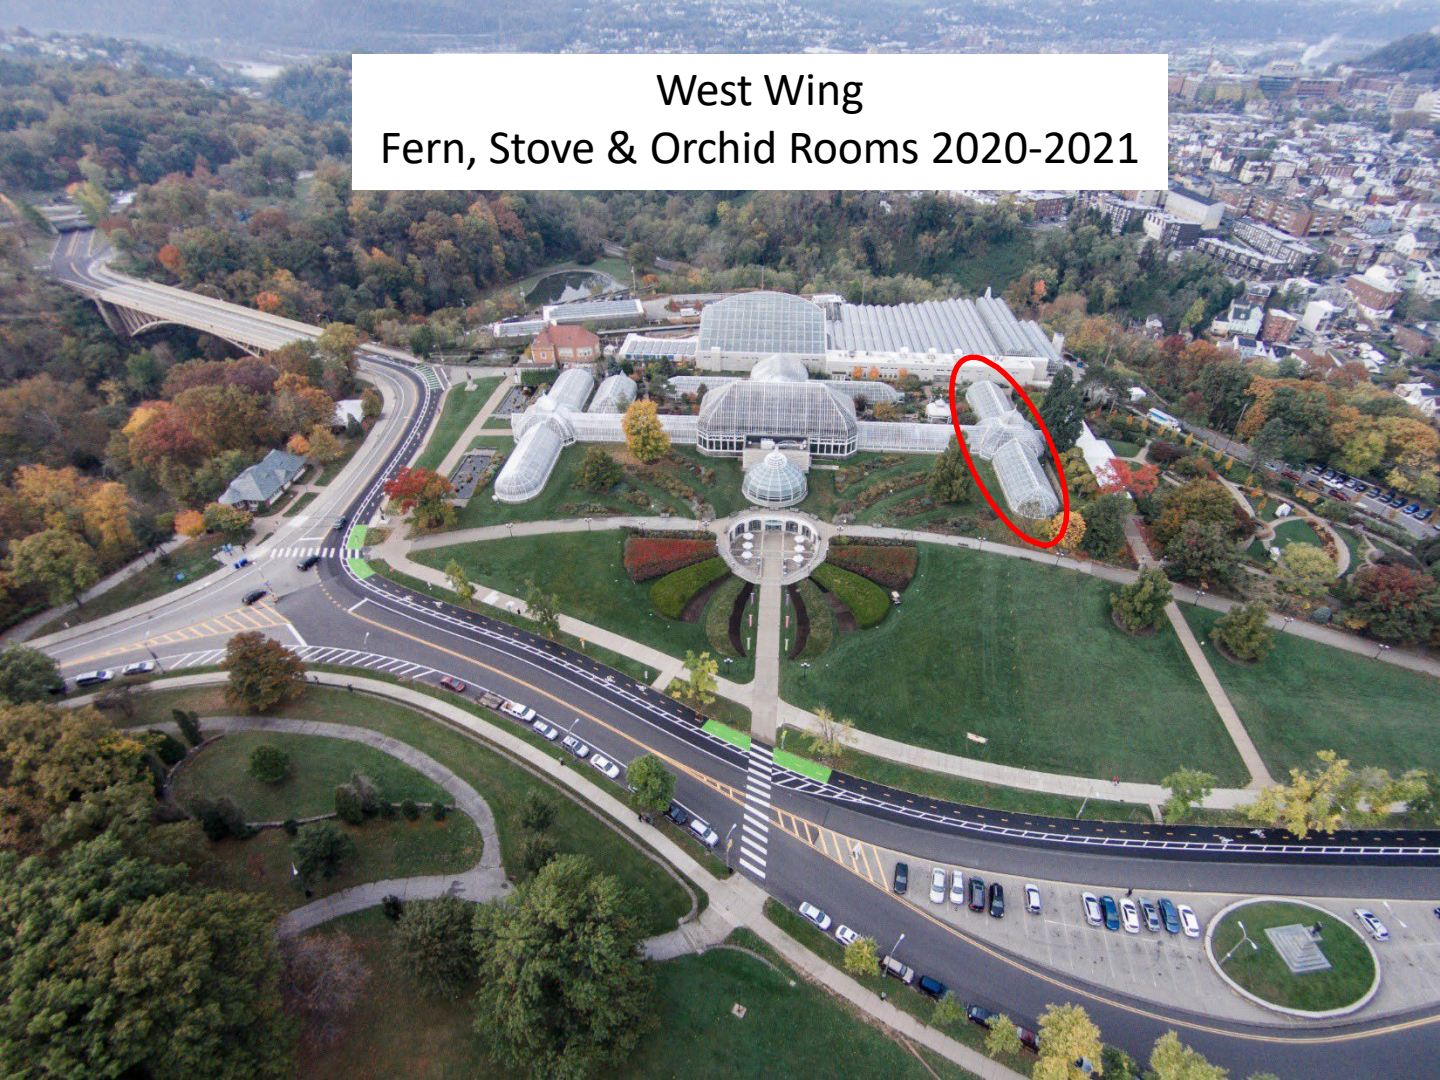
West Wing
Fern, Stove & Orchid Rooms 2020-2021

West Wing - Roof Preservation (2020-21)

Replicated wood rafter profiles in aluminum with high performance white coating, new laminated safety glass, painting/coating of structural elements & gutters, & new insect screening & vent motors .

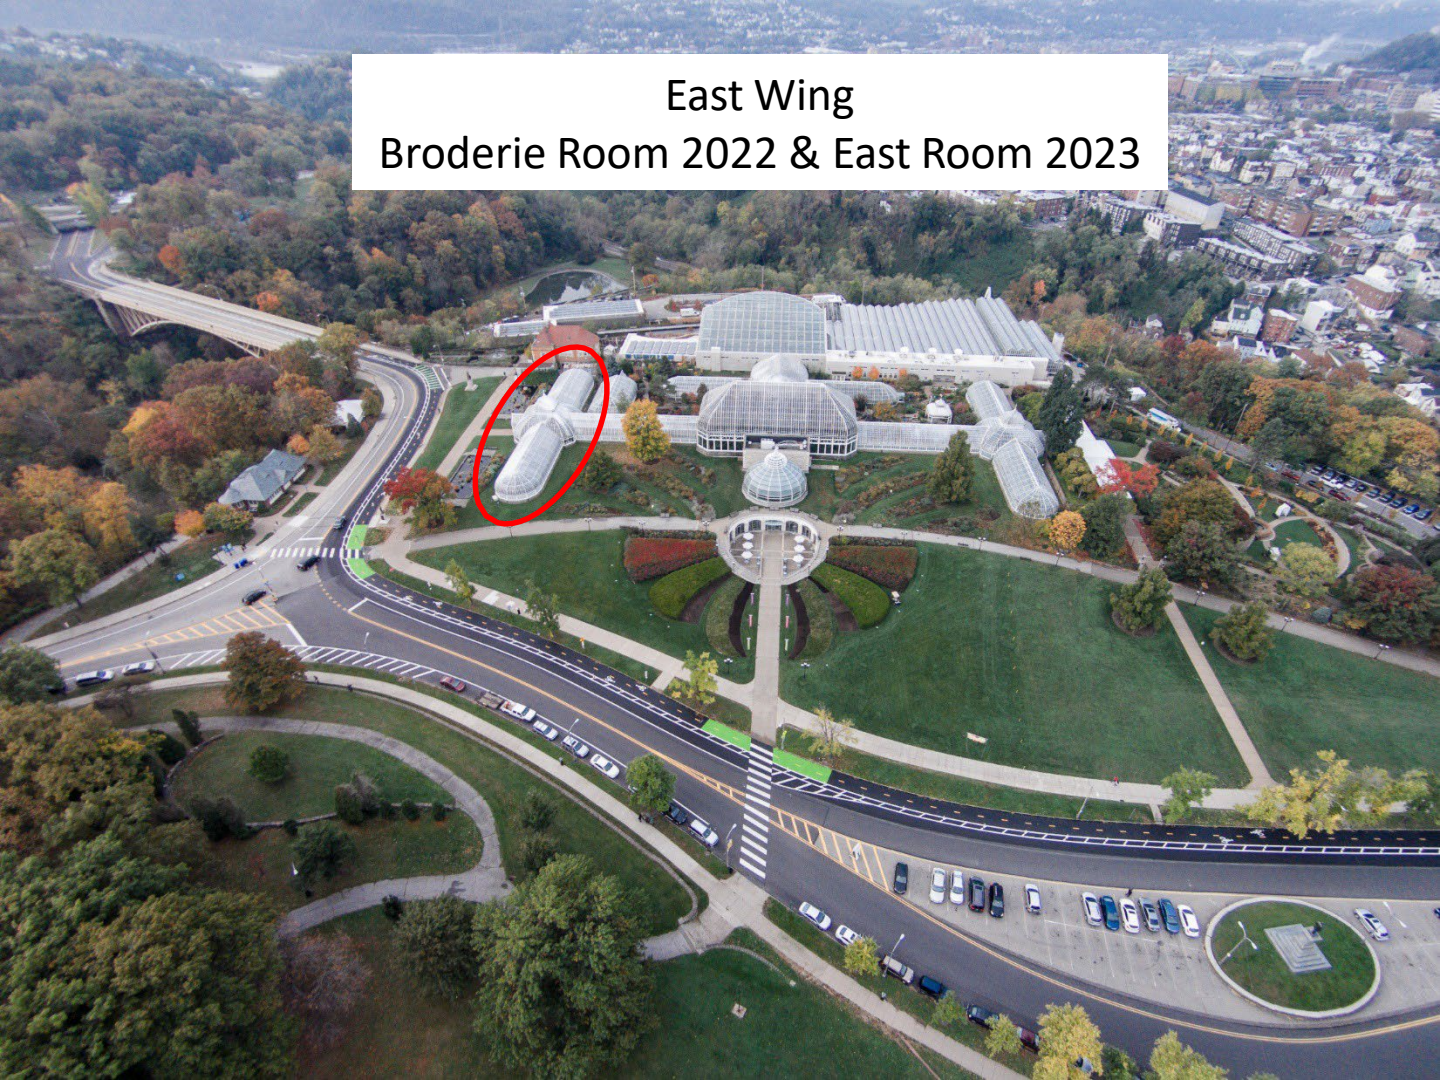
East Wing
Broderie Room 2022 & East Room 2023

East Wing – Broderie Restoration

Replicated wood rafter profiles in aluminum with high performance white coating, new laminated safety glass, painting/coating of structural elements, new gutters, sills, sidewall window vents, critter screening & vent motors .

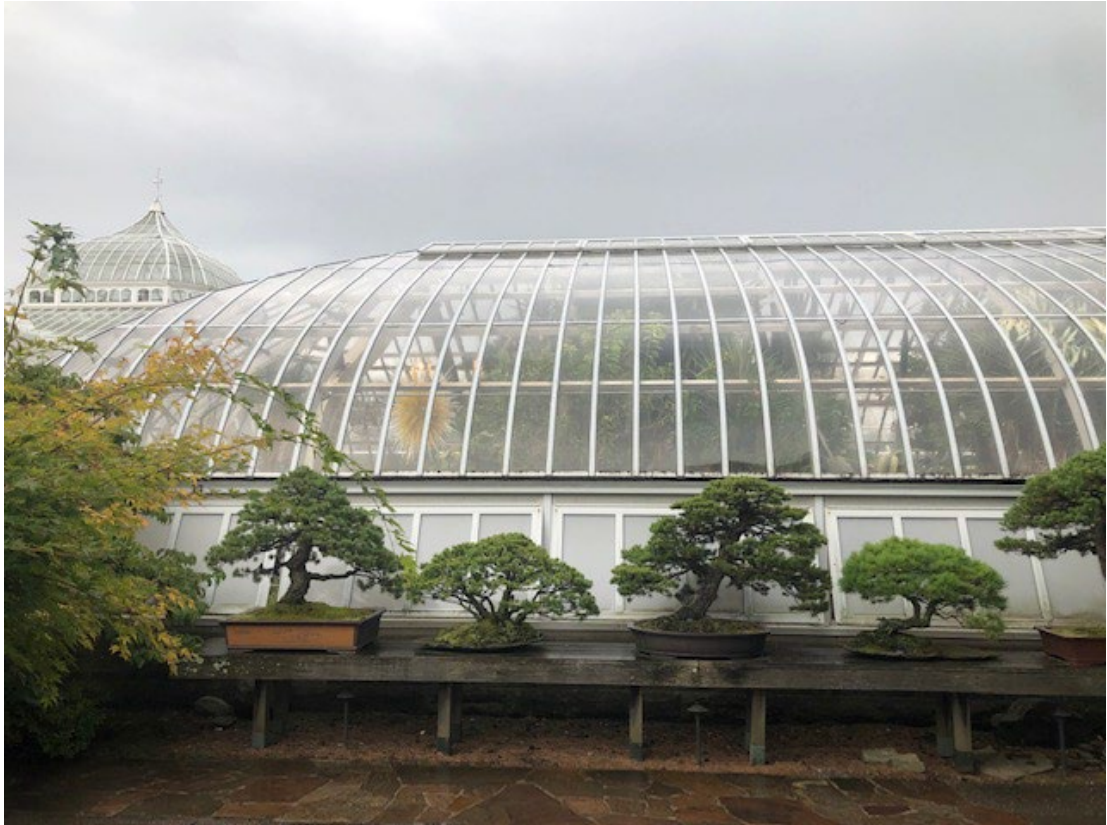
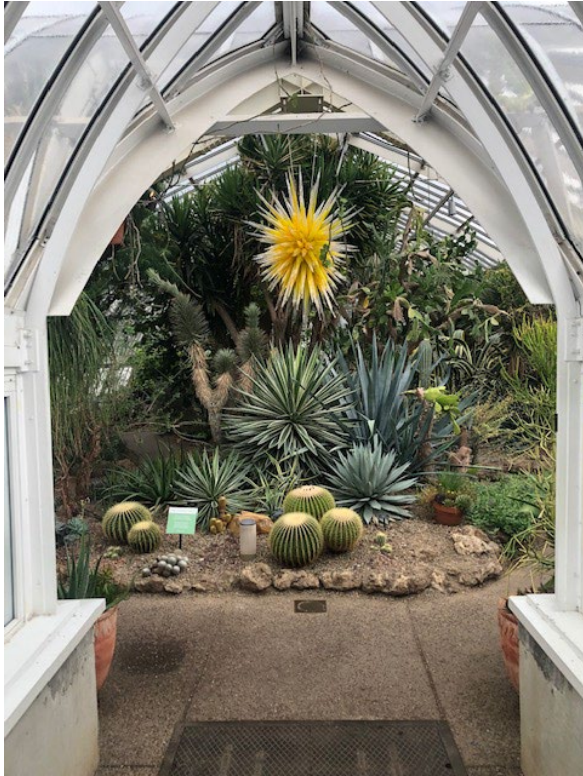
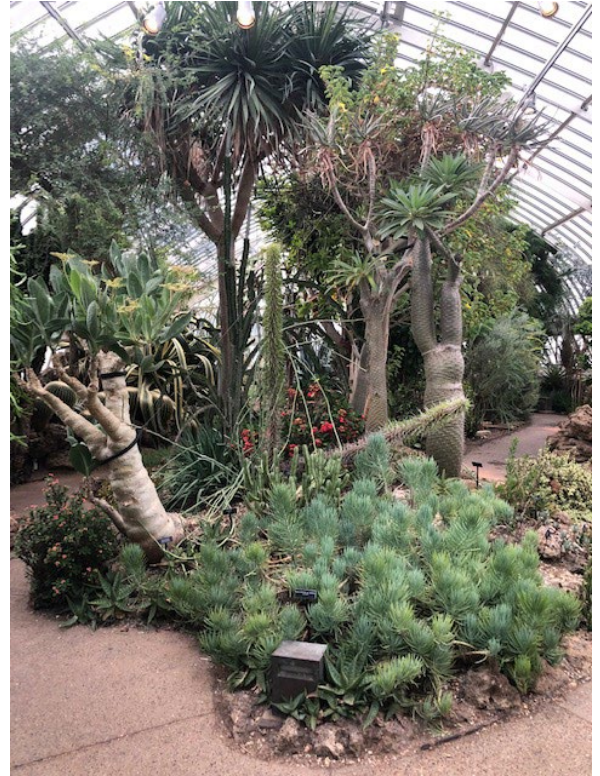
East Wing – Desert Room

- East Wing last renovated in 1988
- Work did not conform to historic Victorian glasshouse standard (rafter spacing, barcaps, plexiglass)
- Victoria Room first restored to historic standard in 2002
- Broderie Room restoration in 2022
- East and Desert Room restorations planned for 2023

- Removal of the existing roof plexiglass glazing, rafters, and flashings.
- Removal of gutters, sills, and sidewall window vents.
- Cleaning and repairing of the steel and cast iron structure and gutters.
- Painting of the steel and cast iron with a high performance paint coating.
- Installation of replicated aluminum roof rafters to match original wood rafters.
- Installation of new flashings, gutter adapters and glazing systems connectors.
- Installation of new gutters, sills, and sidewall window vents.
- Installation of new laminated safety glass with aluminum bar caps.
- Installation of new high efficiency LED lighting and de-stratification fans
